# Walk Around

## Focke-Wulf Fw 190A/F

Walk Around Number 22  
squadron/signal publications

By Malcolm Laing and E. Brown Ryle

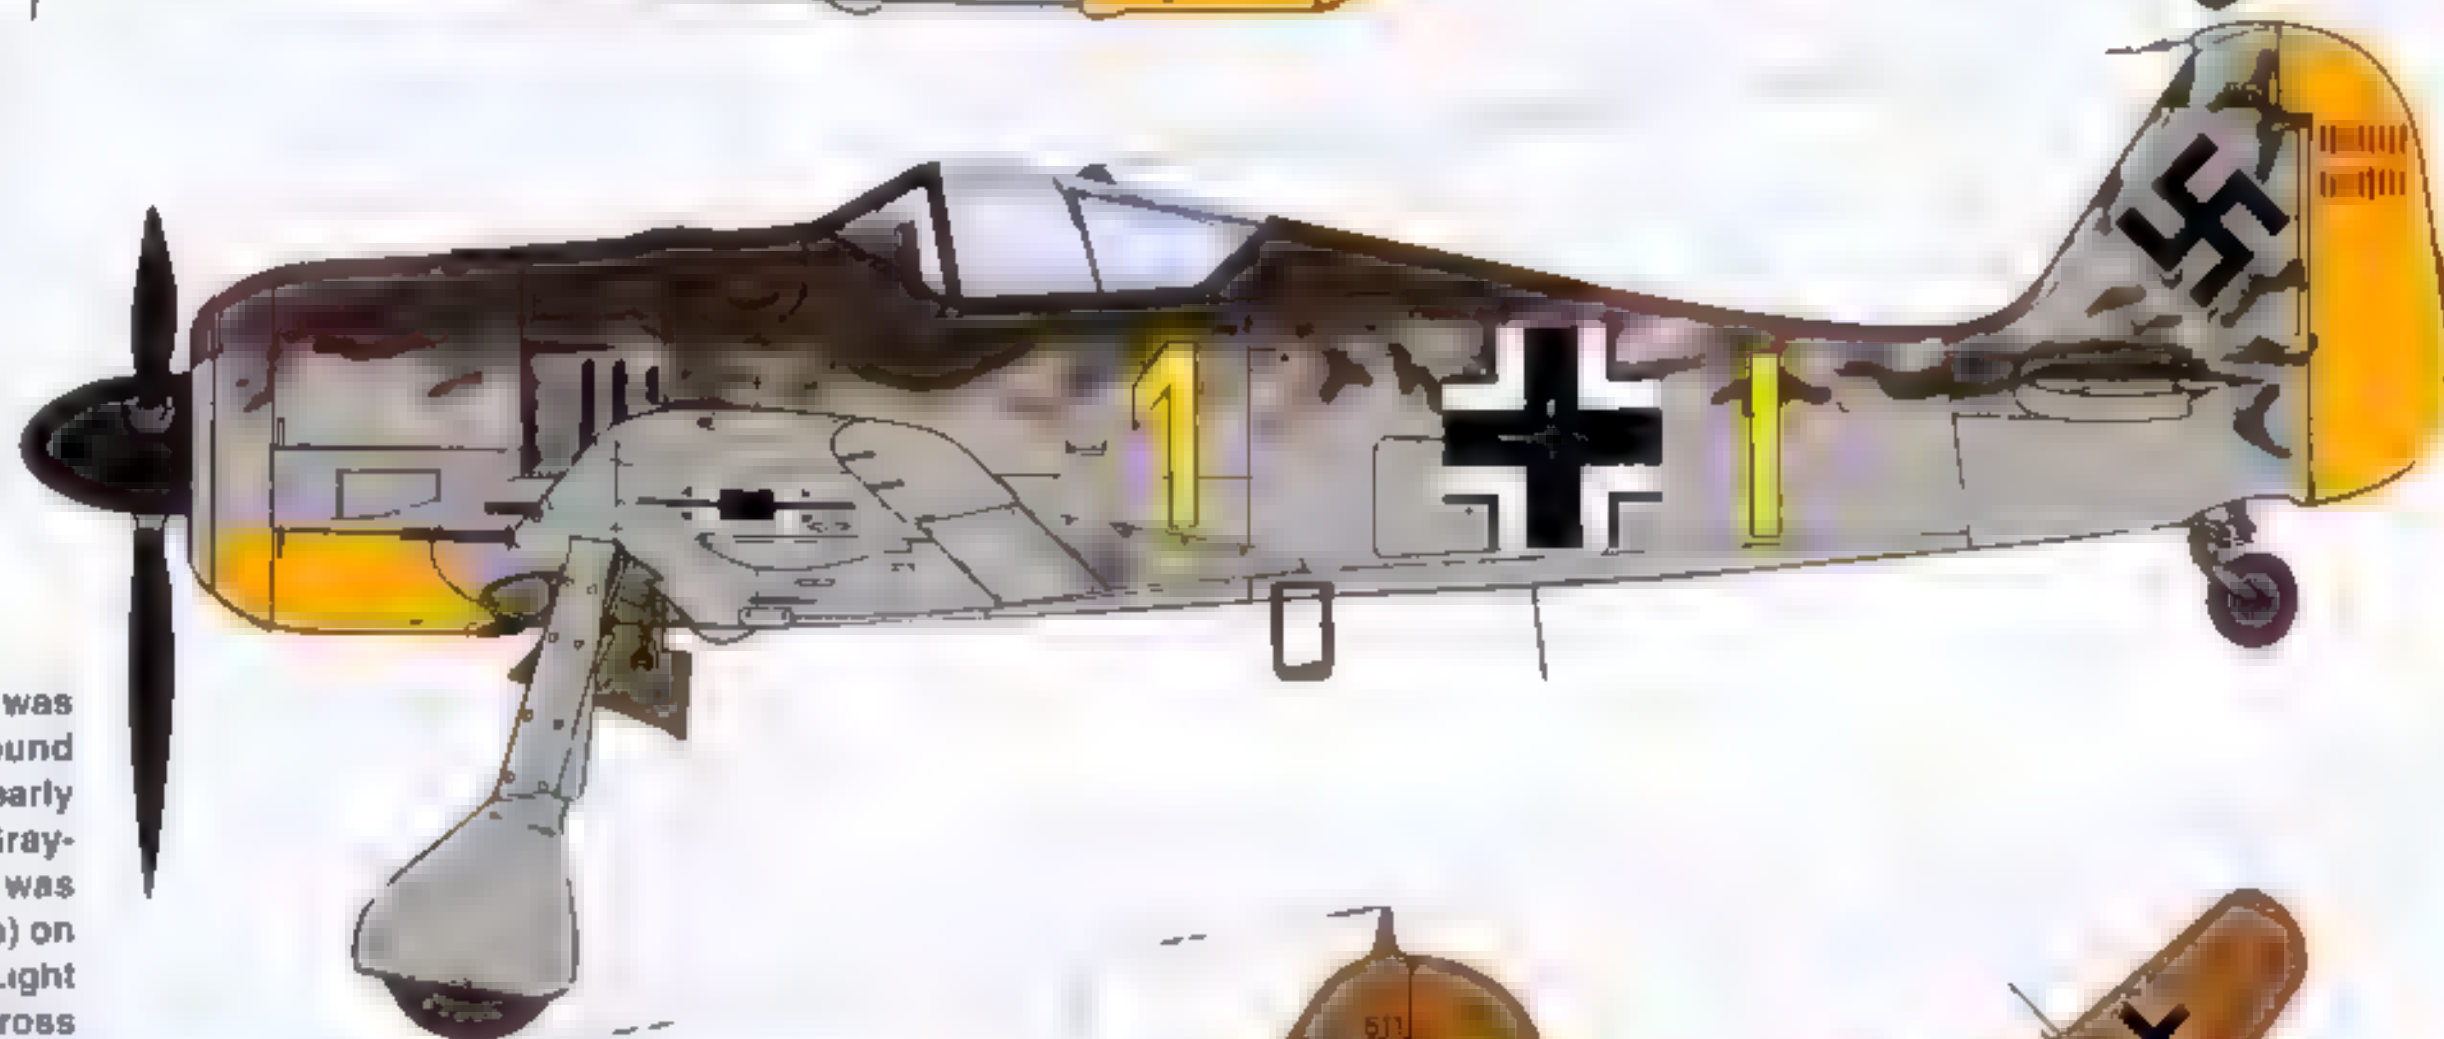
Fw 190A-3, Yellow 1 (W.Nr. 551) was flown by Oberleutnant Kurt Ruppert of 9. Staffel, III/JG 26 against the Allied raid on Dieppe, France on 19 August 1942. Included among his 18 victory tallies displayed was a Spitfire downed west of Dunkirk, France on 25 July 1942. This 15th victory probably marked the point Ruppert was awarded the German Cross in Gold.

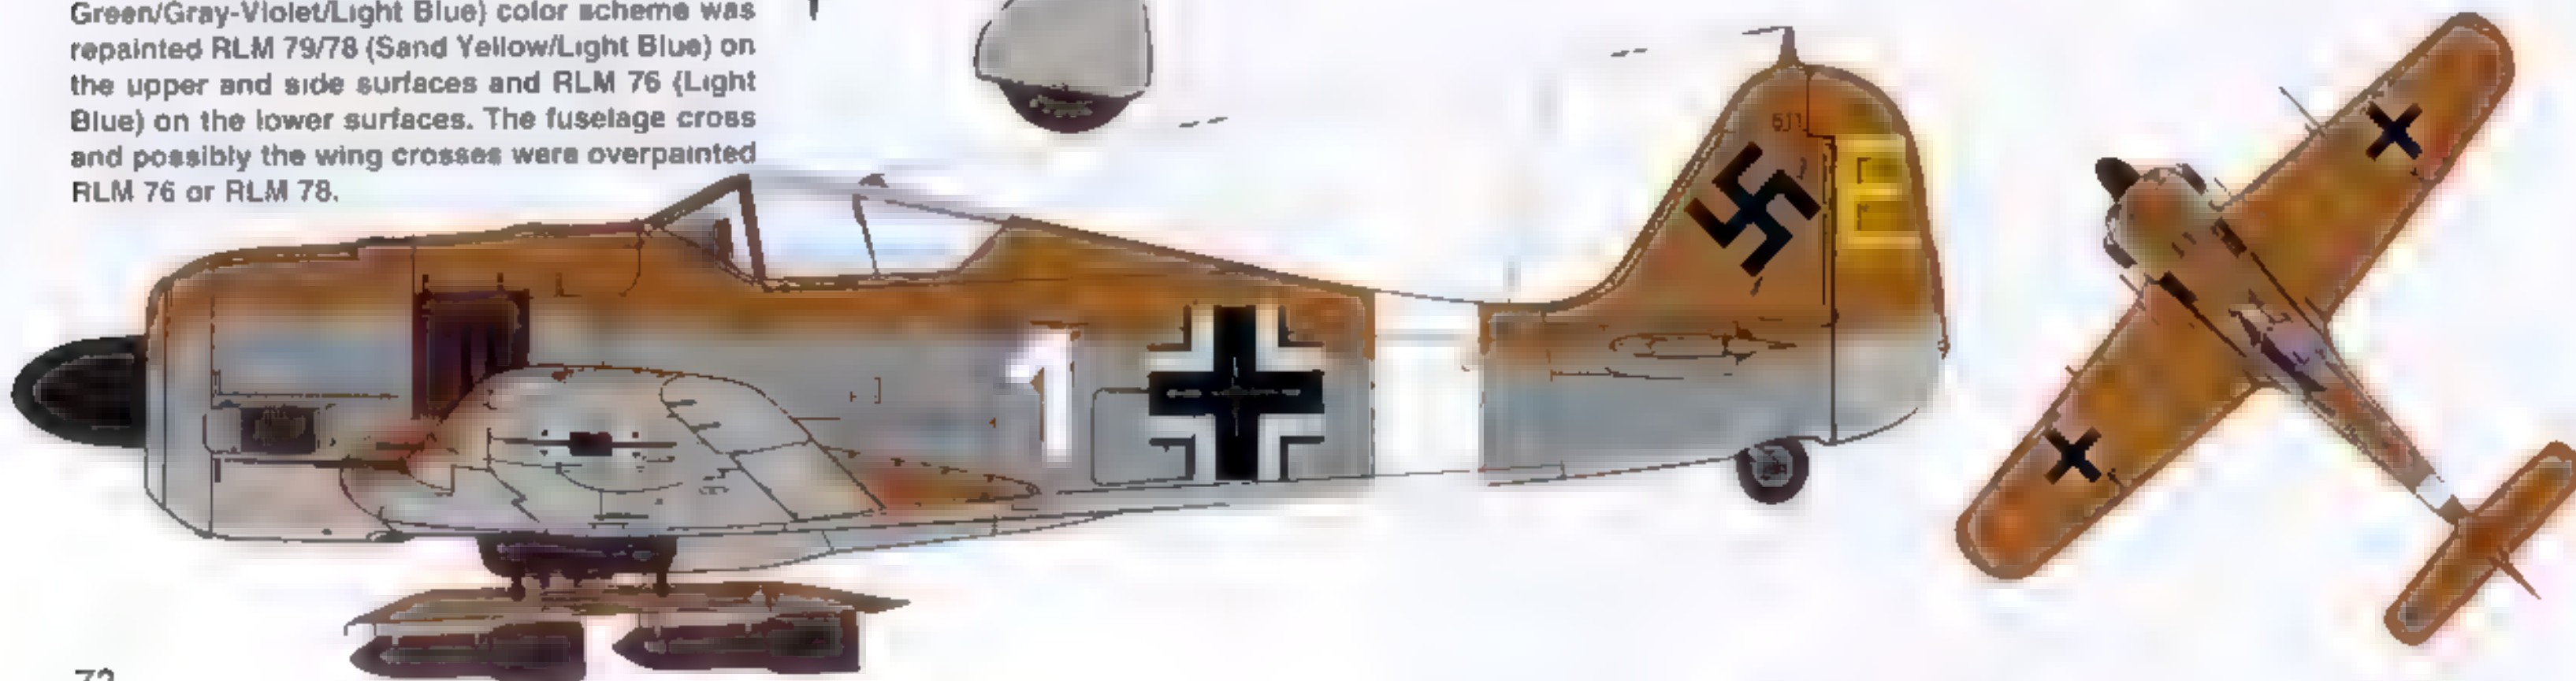
Fw 190A-4/U3 (F1) White 1 (W.Nr. 811) was assigned to a Schlachtgeschwader (Ground Attack Wing), SG 2 or SG 10, in Tunisia in early 1943. The fighter's original RLM 74/75/76 (Gray-Green/Gray-Violet/Light Blue) color scheme was repainted RLM 79/78 (Sand Yellow/Light Blue) on the upper and side surfaces and RLM 76 (Light Blue) on the lower surfaces. The fuselage cross and possibly the wing crosses were overpainted RLM 76 or RLM 78.

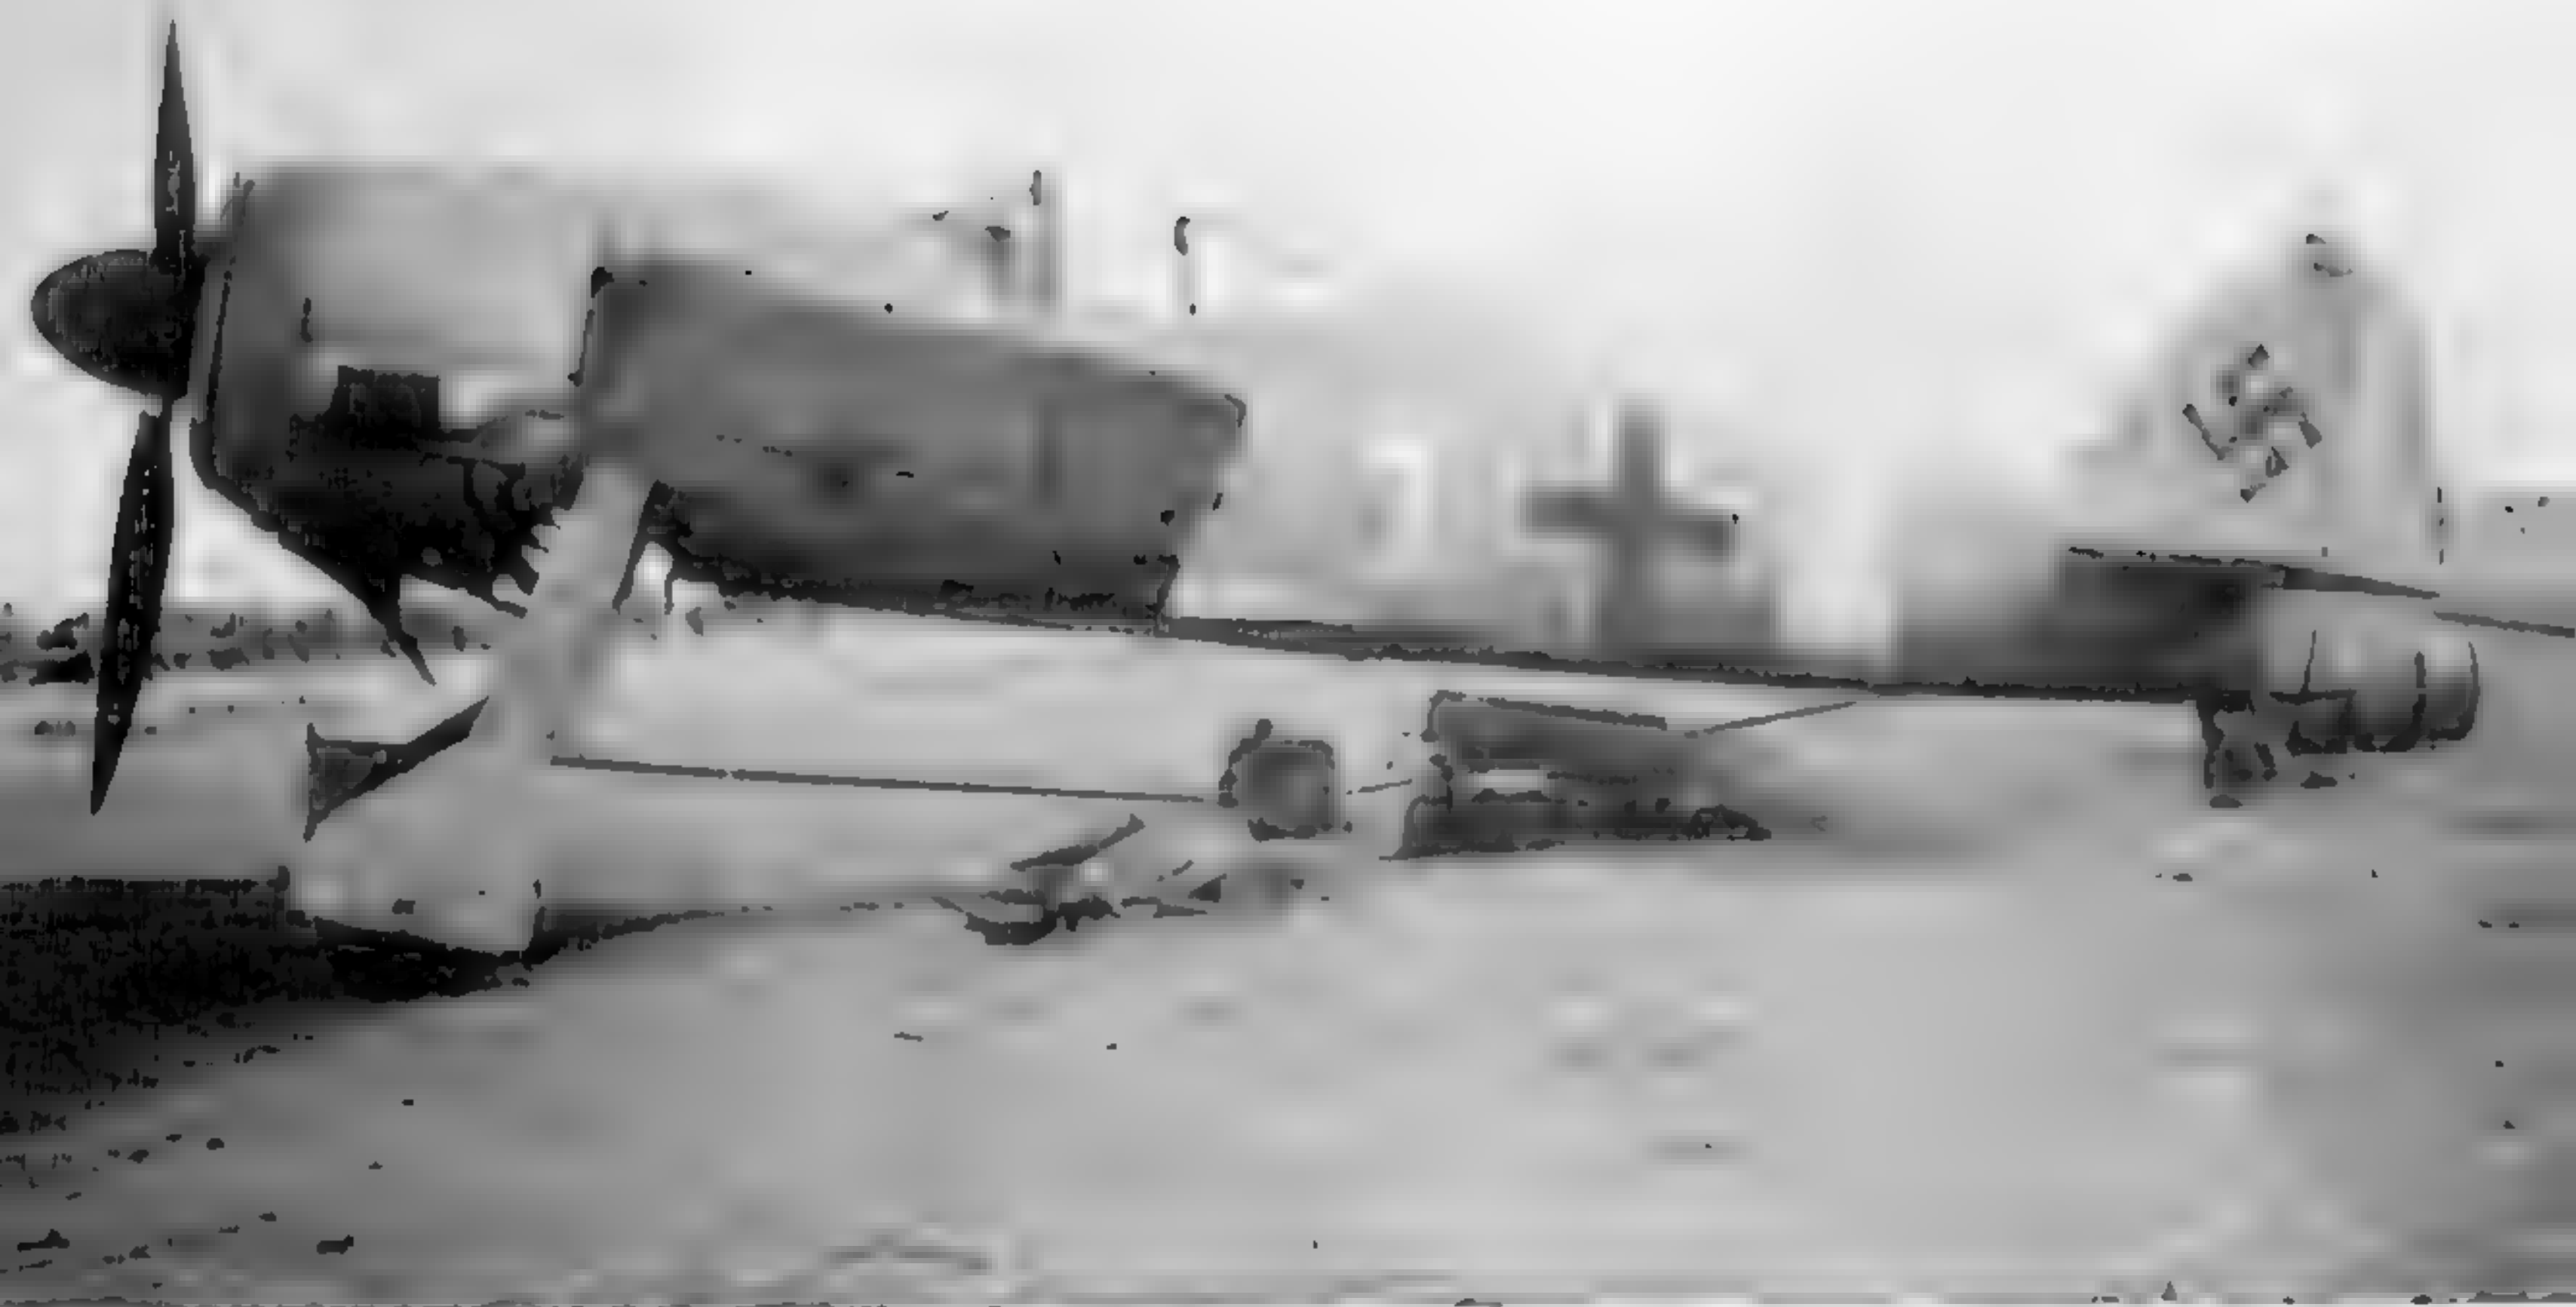
Personnel of the 93rd Fighter Squadron, 81st Fighter Group captured this rare Fw190A-4/U3, White 1/Yellow E (W.Nr. 611) in Tunisia in 1943. This aircraft was assigned to either SG 2 or SG 10 and was fitted with sand filters to its engine intakes. The RLM 79 Sand Yellow upper surfaces wrap around the wing leading edges. Remains of the Fw 190's bomb rack are placed under the fuselage (Fochuk)

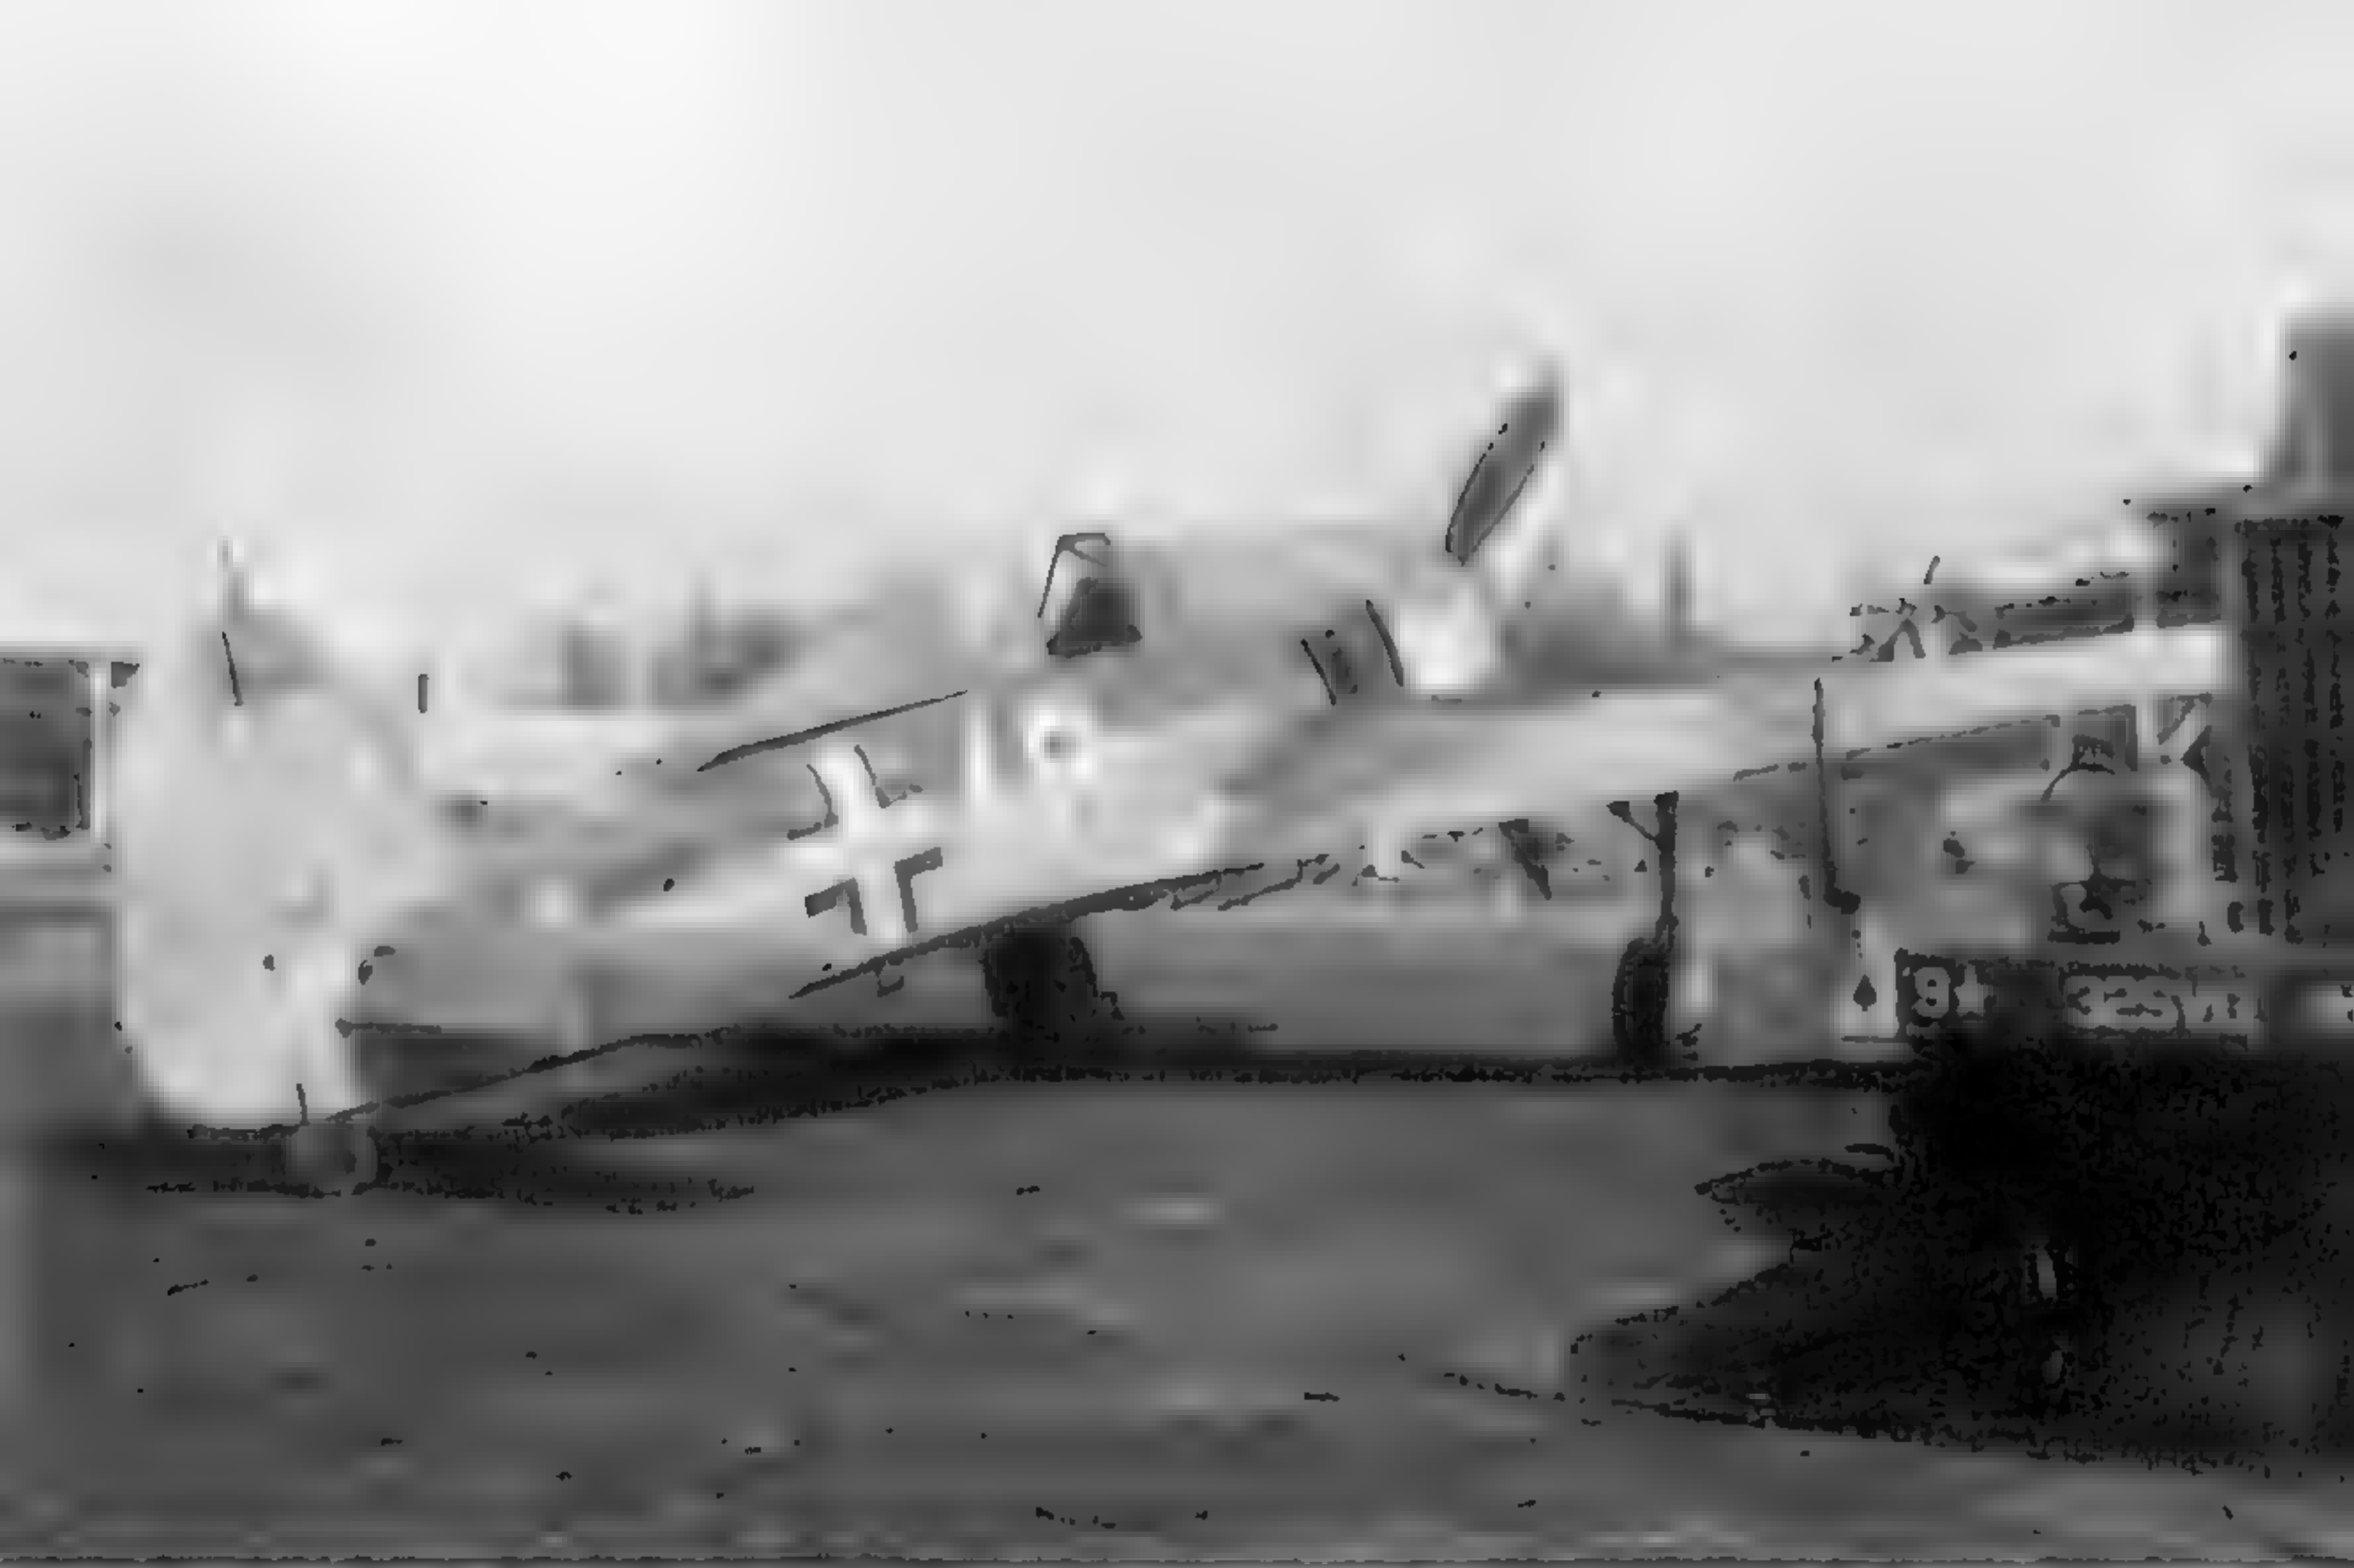
**Fw 190F-8/R1, White 48 (W.Nr. 587108) was assigned to an unknown fighter unit when it was captured by US troops. The captured aircraft was parked at Lippstadt, Germany in May and June of 1945. The Fw 190's tail wheel was not fully extended or the tail wheel strut had lost pressure; however, the rest of this aircraft is in good condition. (Crow)**

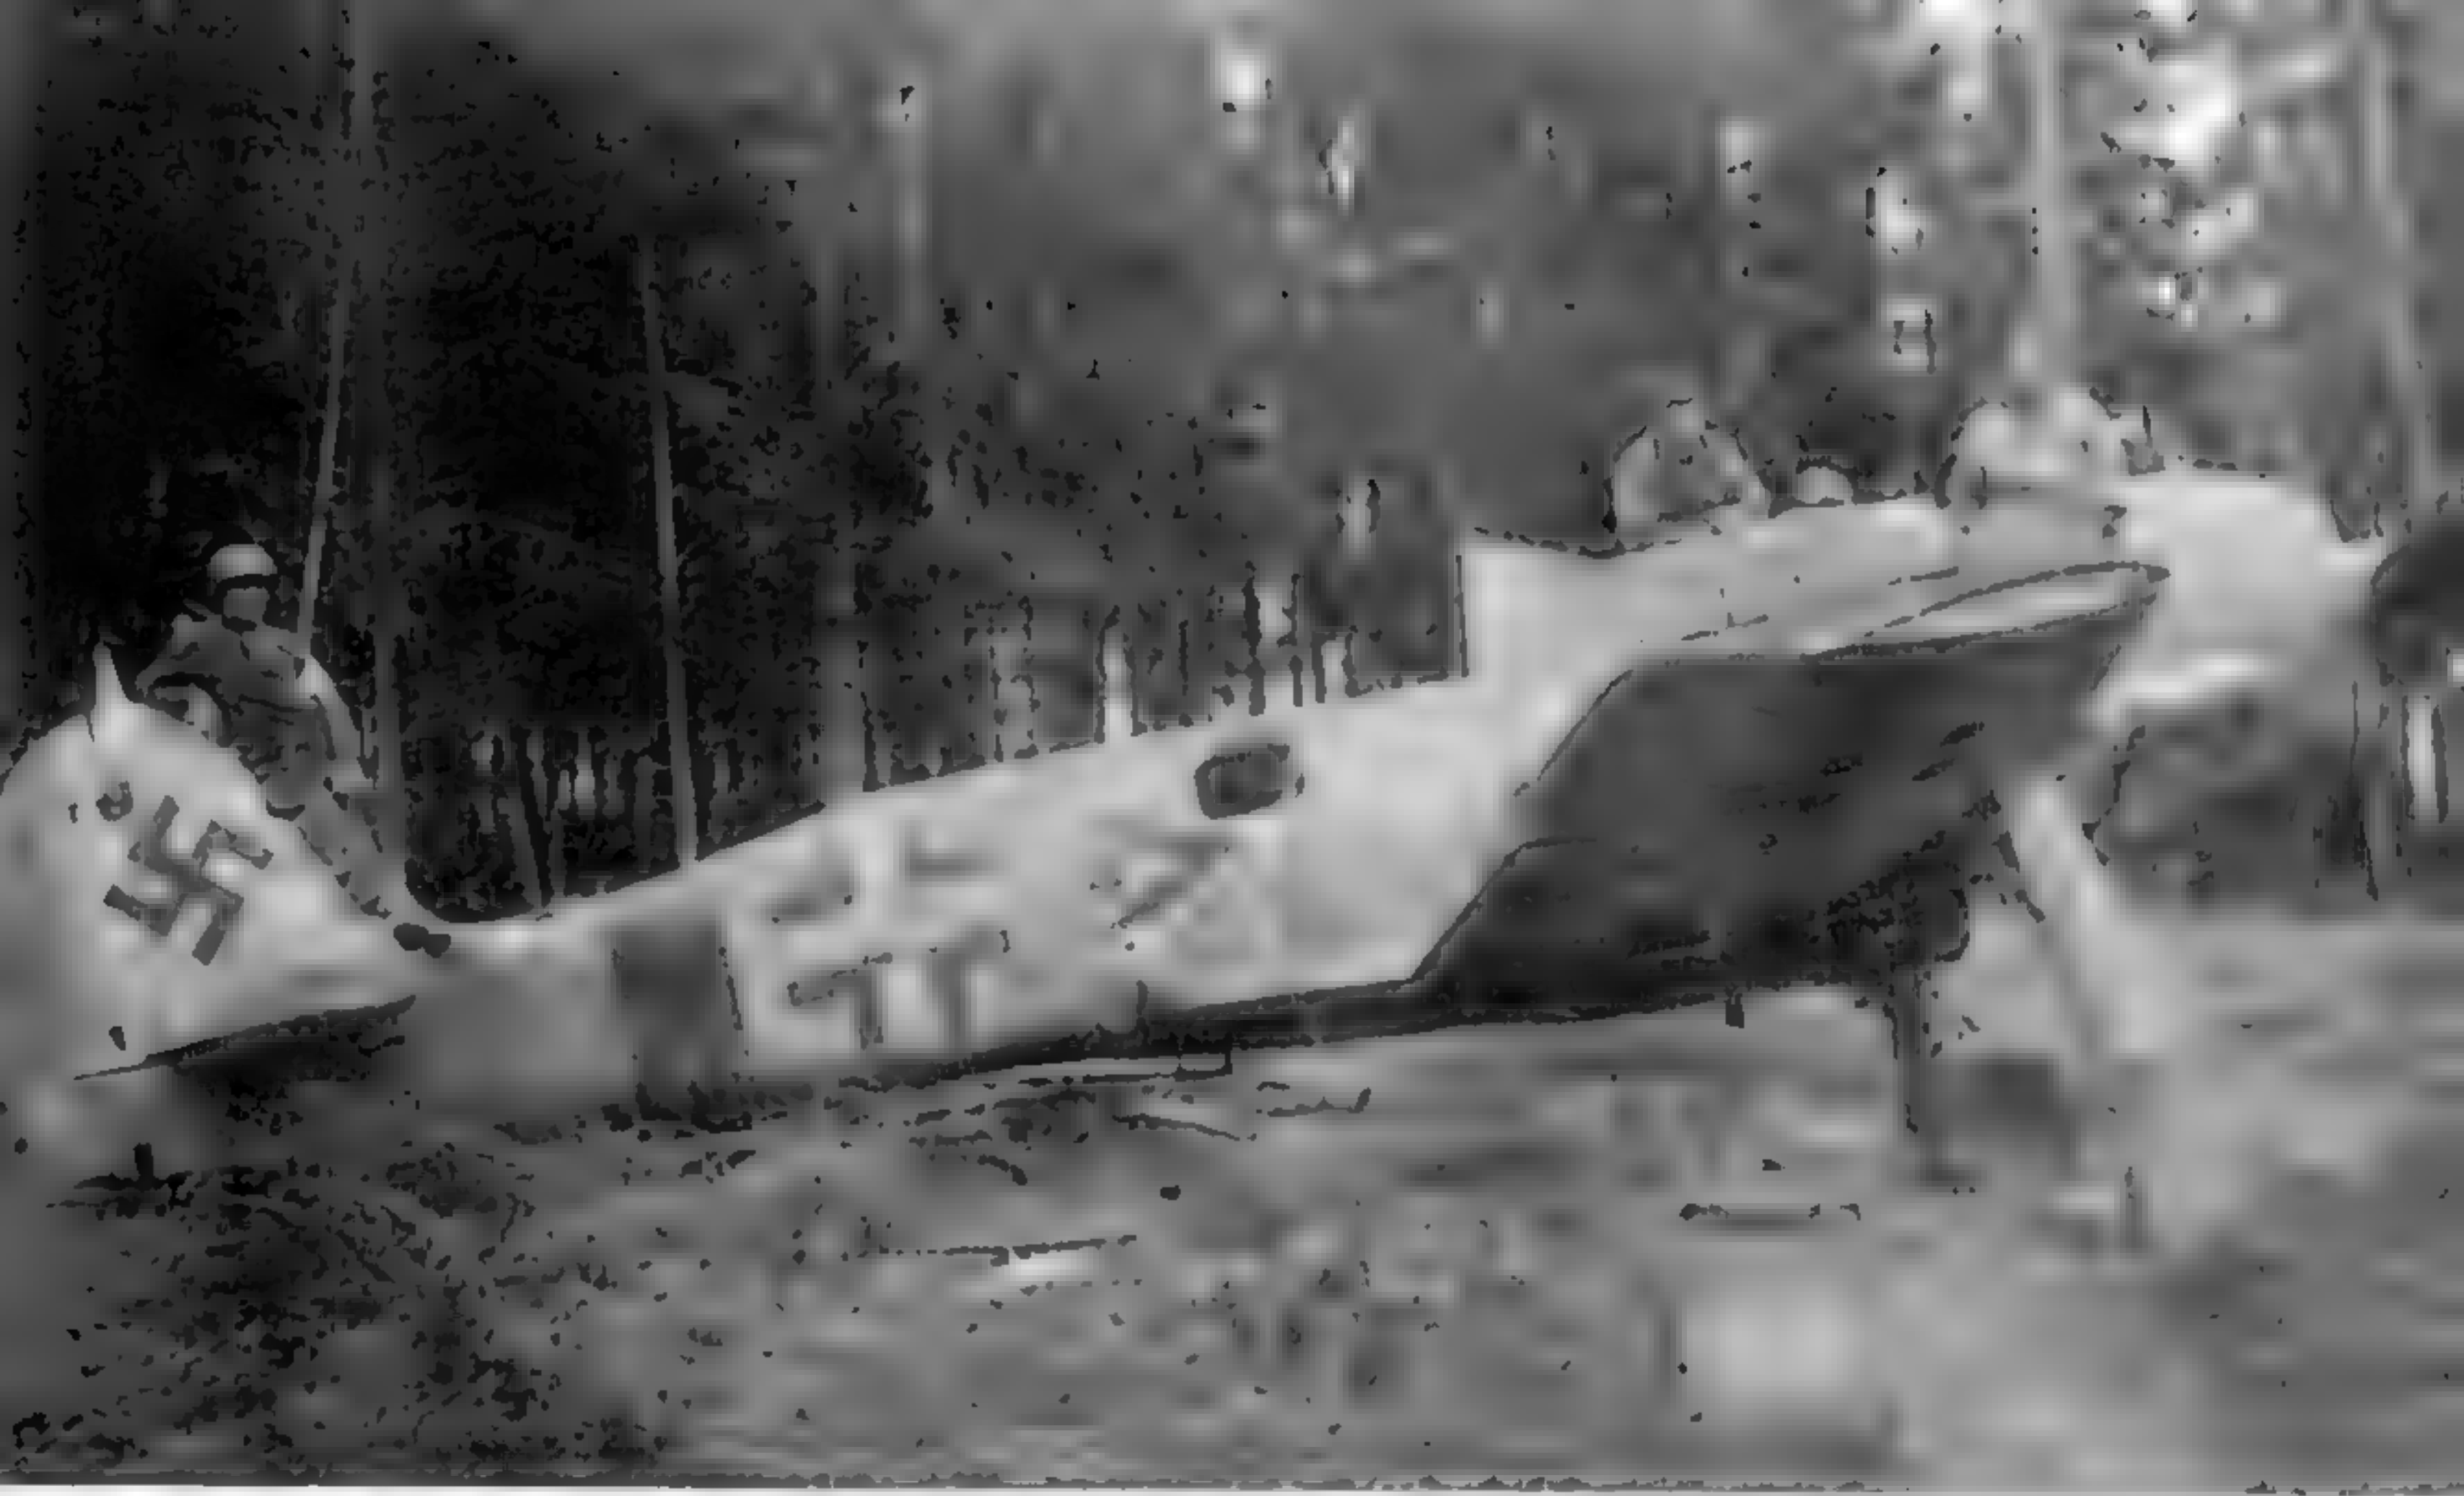
Fw 190F-8, Black Chevron 4, was assigned to (Stab; Staff) 1./JG 301 in Germany during the spring of 1945. US troops found the aircraft in its forest airfield revetment. The Fw 190F-8's seat lay outboard of the starboard wingtip. The canopy, radio compartment access panel, and wingtip cap were removed. (Crow)

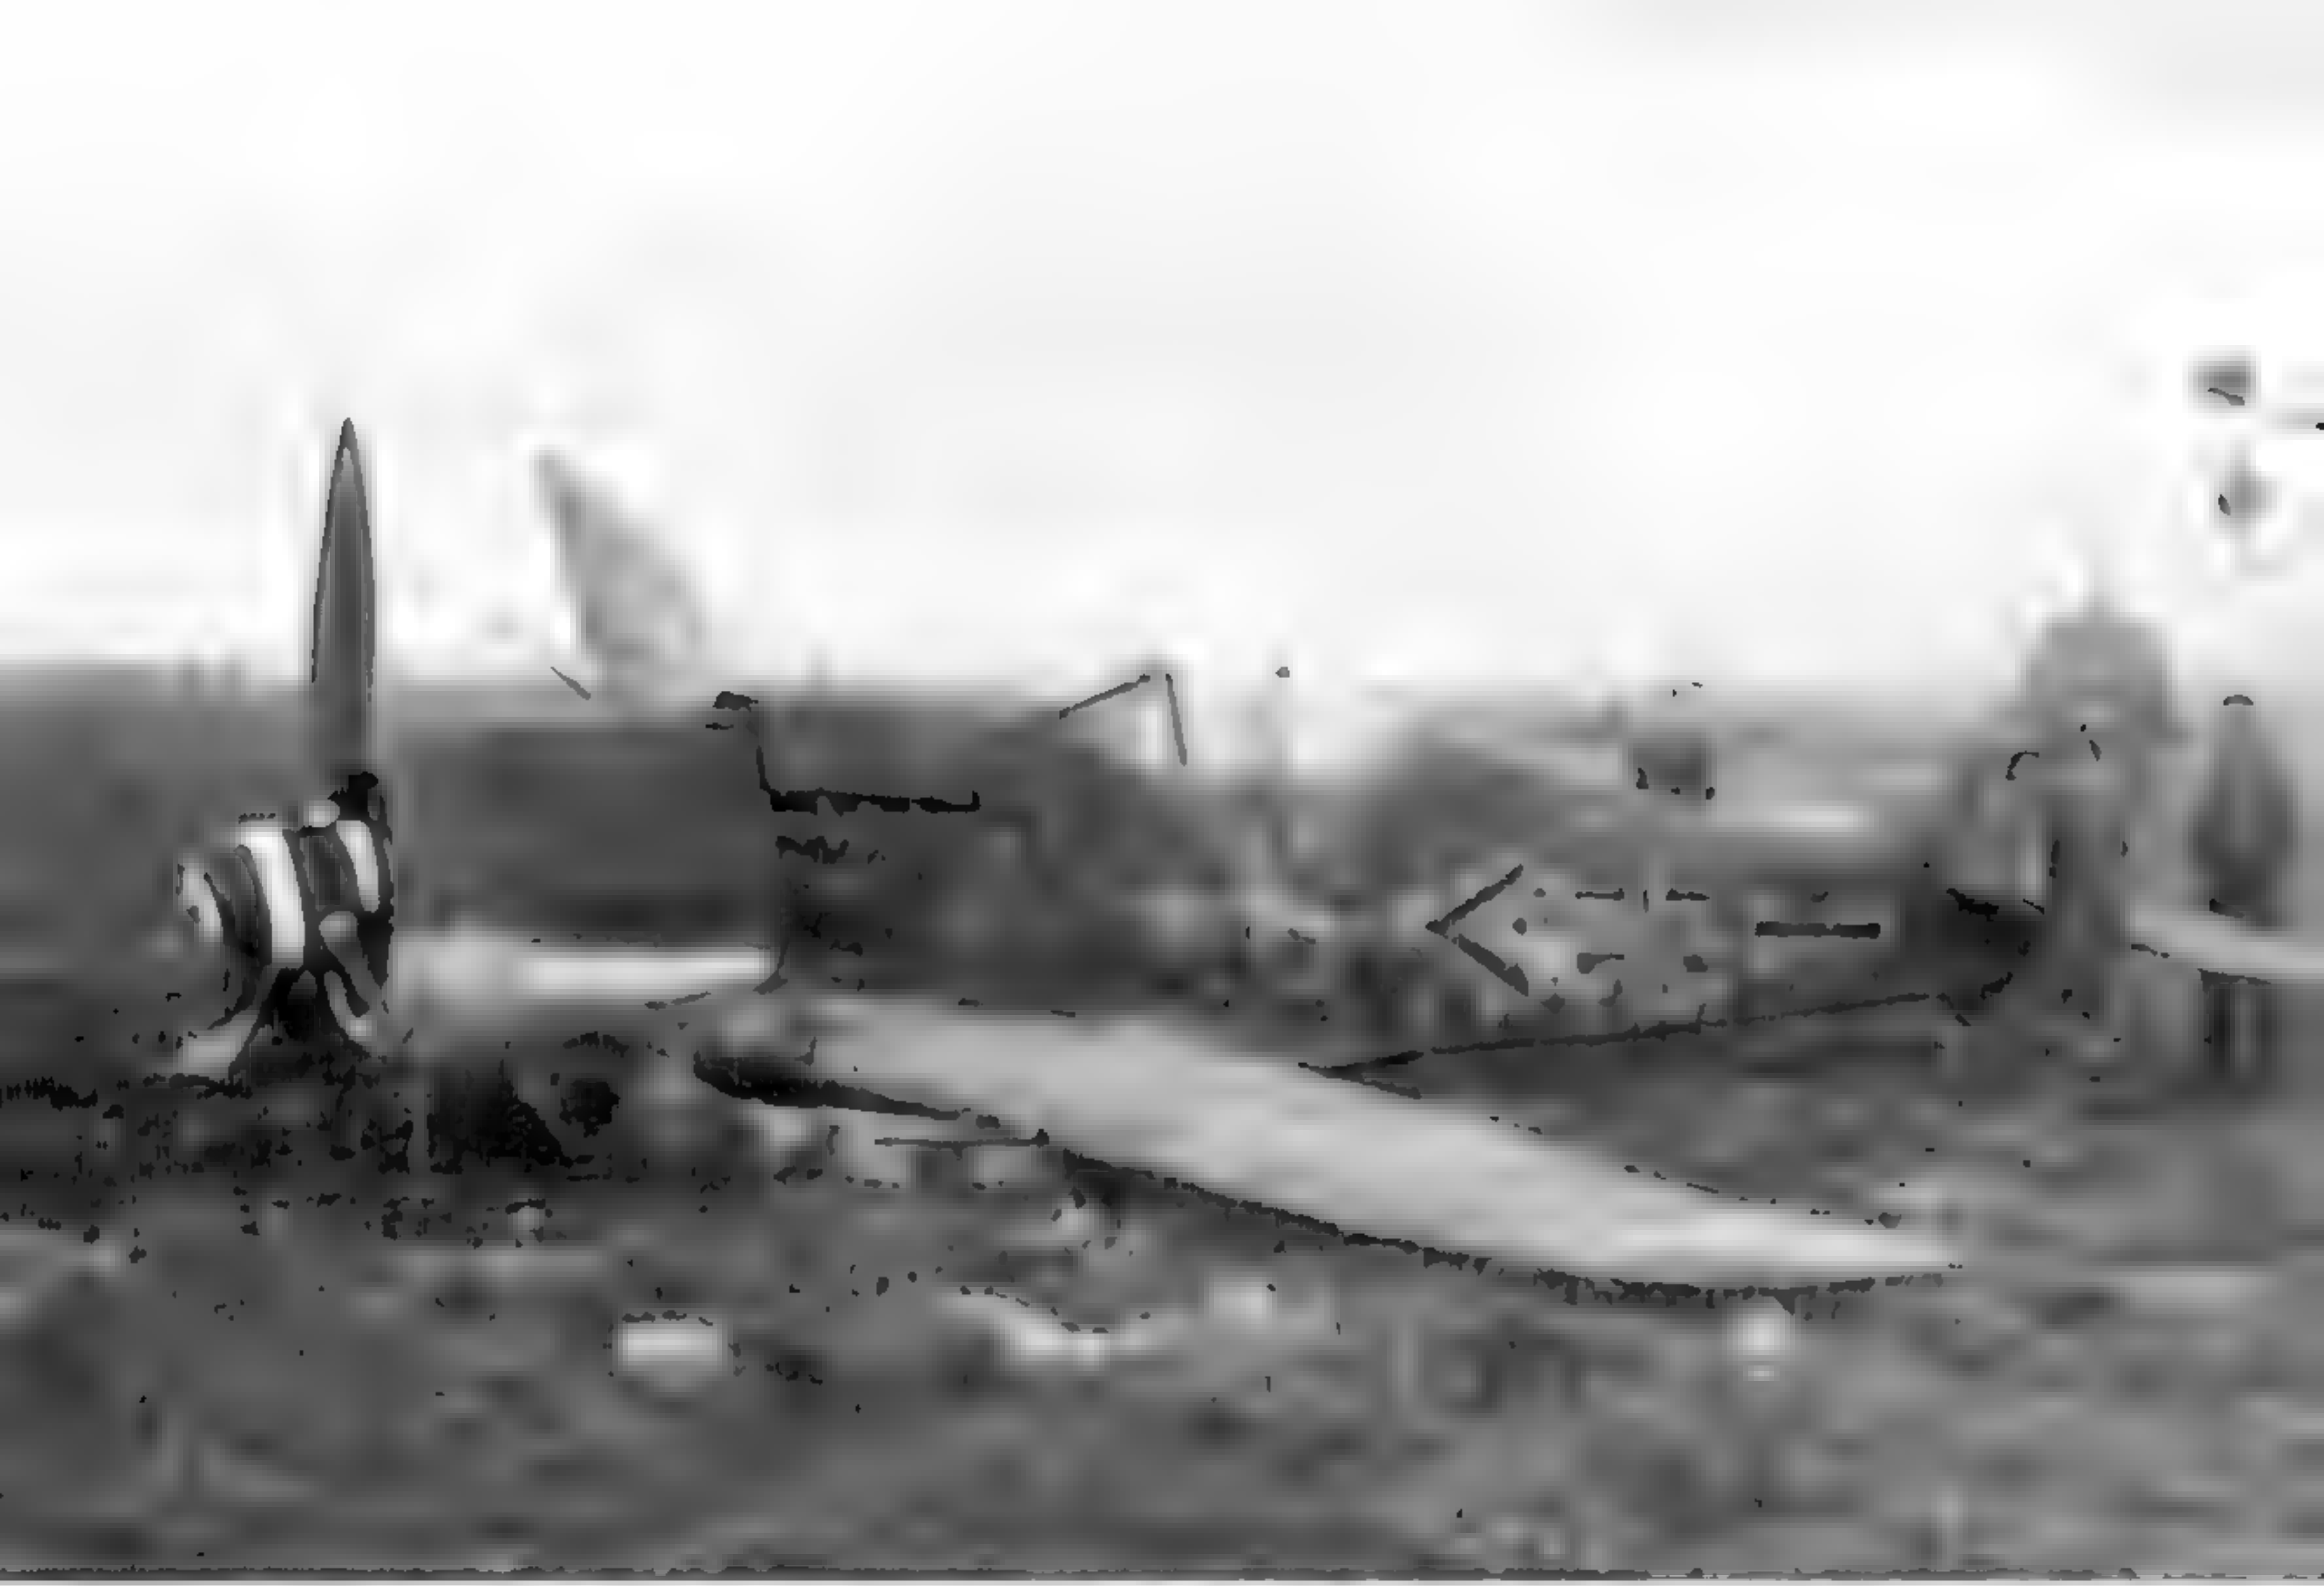
**Fw 190A-8 (W.Nr. 171189) was assigned to (Stab) II./SG 2 when it crash landed at Kitzingen, Germany on 8 May 1945. The aircraft had a field applied camouflage scheme over the factory camouflage scheme – a frequent occurrence by the end of the war. The field-applied scheme was intended to help hide the aircraft while on the ground. Fuselage**

This Fw 190A-8 (W.Nr. 171189) was assigned to (Stab) II/SG 2 when *Major* Karl Kennel crash-landed it at Kitzingen, Germany on 8 May 1945 – the day World War II ended in Europe. Although equipped with an outboard 20mm MG151 cannon, the bulged access panel beneath the wing is associated with 30mm weapons. A second ejection chute has been cut into the 30mm panel to allow ejection of the spent 20mm shells. This is another view of the same aircraft seen on page 75. (Crow)
